Longwall Gate Road Stability in a Steeply Pitching Thick Coal Seam With a Weak Roof

Report of Investigations 9580

By Lance R. Barron and Matthew J. DeMarco

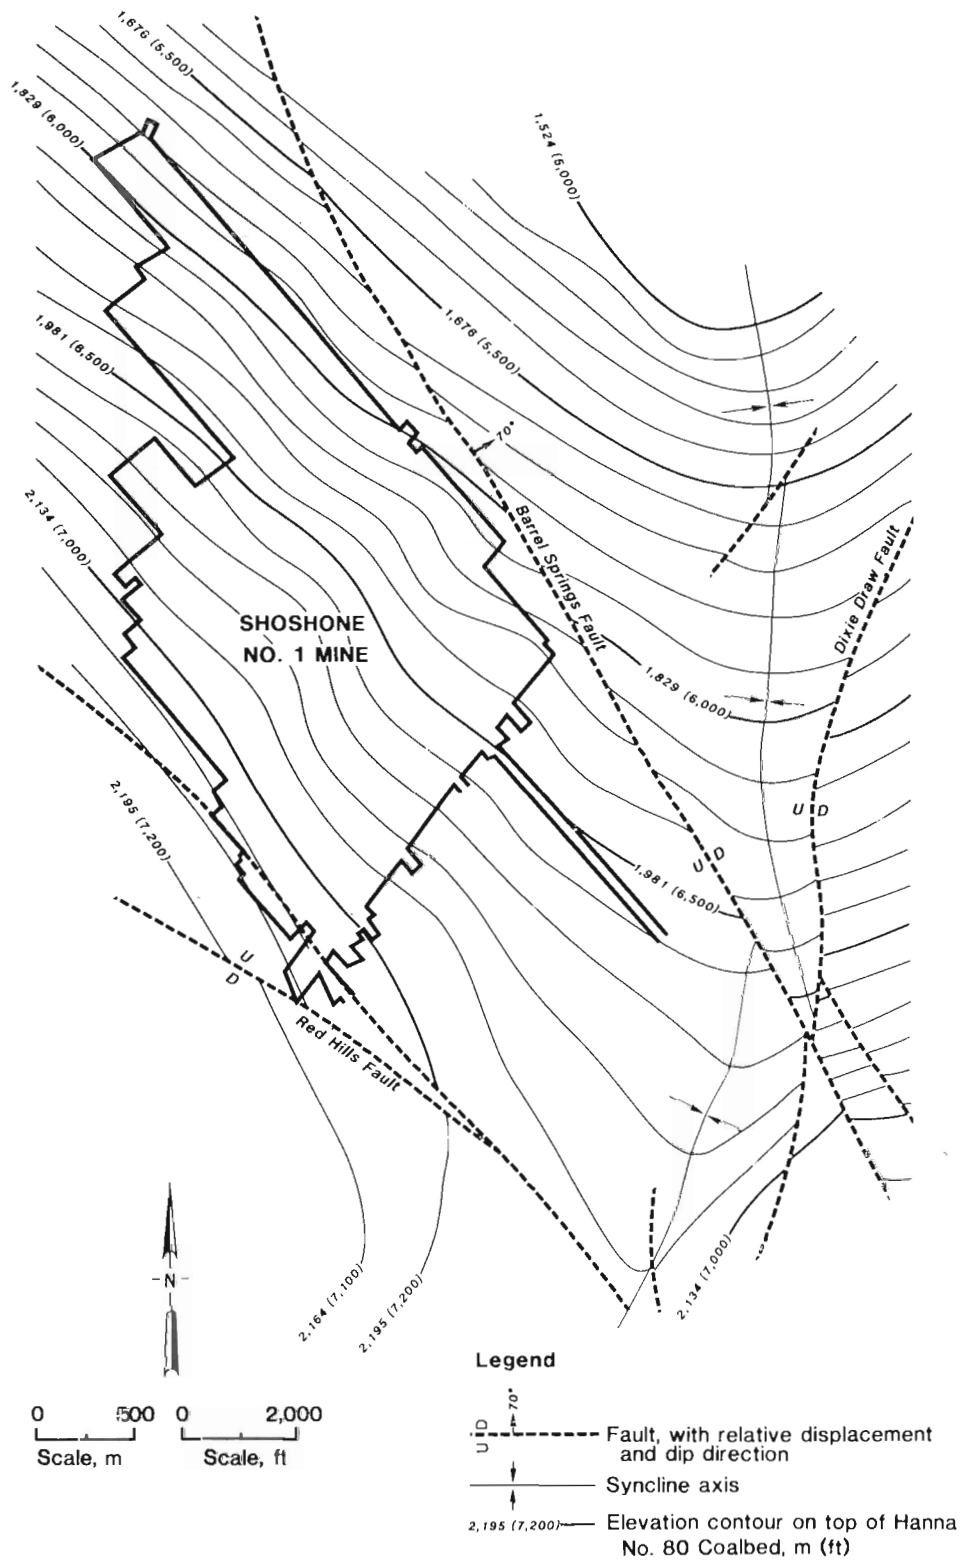
Figure 2

Geologic structure at Shoshone No. 1 Mine. [Modified from Glass (3)]

Three faults are present in the mine area, as shown in figure 2. The Red Hills Fault, a northwest-southeast-trending reverse fault with vertical displacements ranging from 7.6 to 9.1 m (25 to 30 ft) (5), lies to the southwest of the mine workings. The Dixie Draw Fault, a northeast-southwest-trending normal fault with approximately 11.3 m (37 ft) of measured vertical displacement (5), is located to the southeast of the mine workings. The Barrel Springs Fault has the greatest effect on the overall mine layout and bounds the farthest downdip extent of the main entries of the mine. This normal fault trends approximately N. 30° W. in the mine area and dips about 70° to the northeast (3). The strata on the northeastern side of this fault have been downthrown an average of 21 m (70 ft) (5), with total vertical displacement ranging from 4.6 m (15 ft) in the southeastern part of the mine area to 30.5 m (100 ft) in the northern part (2).

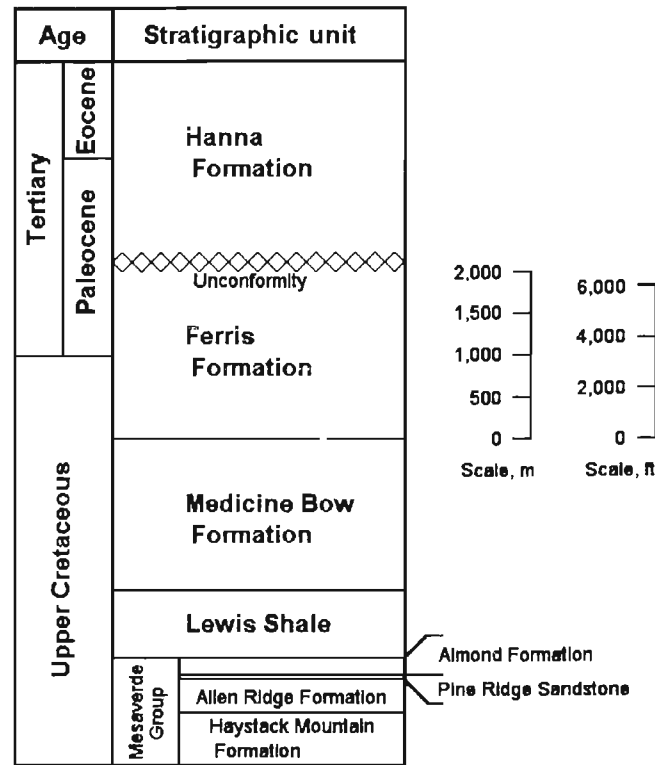
Figure 3

Generalized stratigraphic section for Hanna Basin. [From Glass and Roberts (1)]

In ascending order, the principal stratigraphic units of the Hanna Basin are the Mesaverde Group (composed of the Haystack Mountain Formation, Allen Ridge Formation, Pine Ridge Sandstone, and Almond Formation), the Lewis Shale, and the Medicine Bow, Ferris, and Hanna Formations (8) (figure 3).

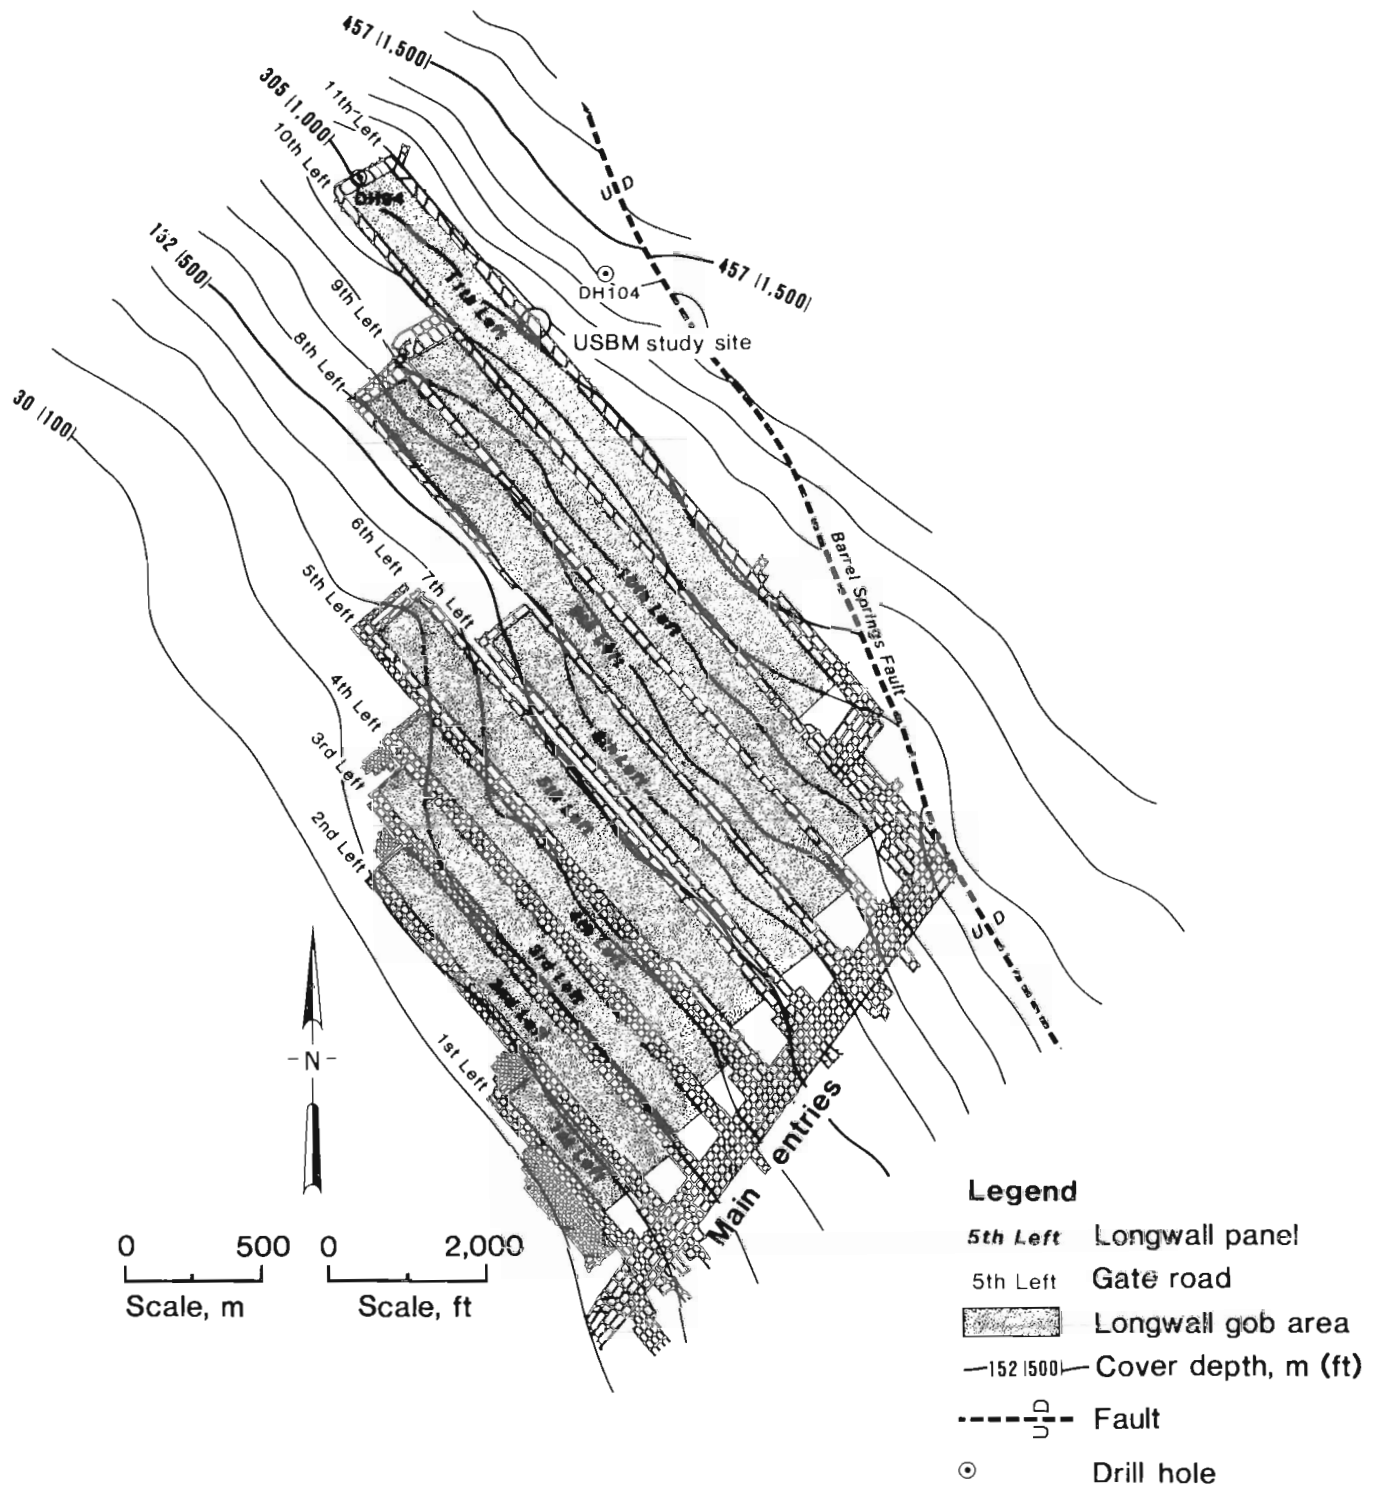
Figure 5

Longwall mining area of Shoshone No. 1 Mine during 1980-94, showing locations of drill holes DH94 and DH104 and USBM study site. (Courtesy Cyprus Shoshone Coal Corp.)

CCCC completely developed the 1st to 6th Left (figure 5) and 1st Right (outside the area shown in figure 5) gate roads. Although CCCC initially planned to use a two-entry gate road design, a lengthy delay in receiving the required regulatory variance (for a two-entry system) necessitated development of the first five gate roads as three-entry systems.⁷ In the 1st to 5th Left gate roads, pillar widths were incrementally increased from 17.7 m (58 ft) in 1st Left (15) [also developed in accordance with the geotechnical study recommendations (5)] to 24 m (80 ft) in 5th Left, primarily in response to increasing mining depth. Small room-and-pillar sections (with no pillar extraction) were developed from 1st to 3rd Left (figure 5) and 1st Right in small areas isolated between these gate roads and abandoned strip mines that bounded the west and northwest sides of the mine reserves. CCCC discontinued this practice because of concern that air might "leak" into these pillar workings from the nearby No. 80 seam "outcrops" in the old strip mines and possibly contribute to spontaneous combustion problems.⁸ Since 1985, continuous miners have only been used for gate road development.⁹ CCCC developed the 6th Left gate road as a two-entry system to minimize the amount of coal remaining in the gob area after the panel was sealed and thus reduce the potential for spontaneous combustion.¹⁰

CSCC extracted the 8th, 9th, and 10th Left panels (figure 5) from 1989 to 1993. Ground control, particularly in the tailgates, became progressively more difficult as mining depth increased to 305 m (1,000 ft).¹⁸ Tailgate conditions were generally good throughout the extraction of the 8th Left panel and the first half of the 9th Left panel; however, when the 9th Left face drew even with the 8th Left panel gob, conditions in the tailgate (8th Left gate road) rapidly worsened and the face advance rate was slowed to install additional secondary support. Poor tailgate ground conditions nevertheless persisted throughout the remainder of the panel, with severe roof cutter often developing along the panel rib, extreme convergence (roof sag) approaching 50% of the original entry height, and gob, containing large blocks that had to be drilled and shot, flushing around the tailgate shield onto the longwall panline. Tailgate conditions throughout the 10th Left panel retreat were equally as unfavorable as those encountered in the second half of the 9th Left longwall.¹⁹

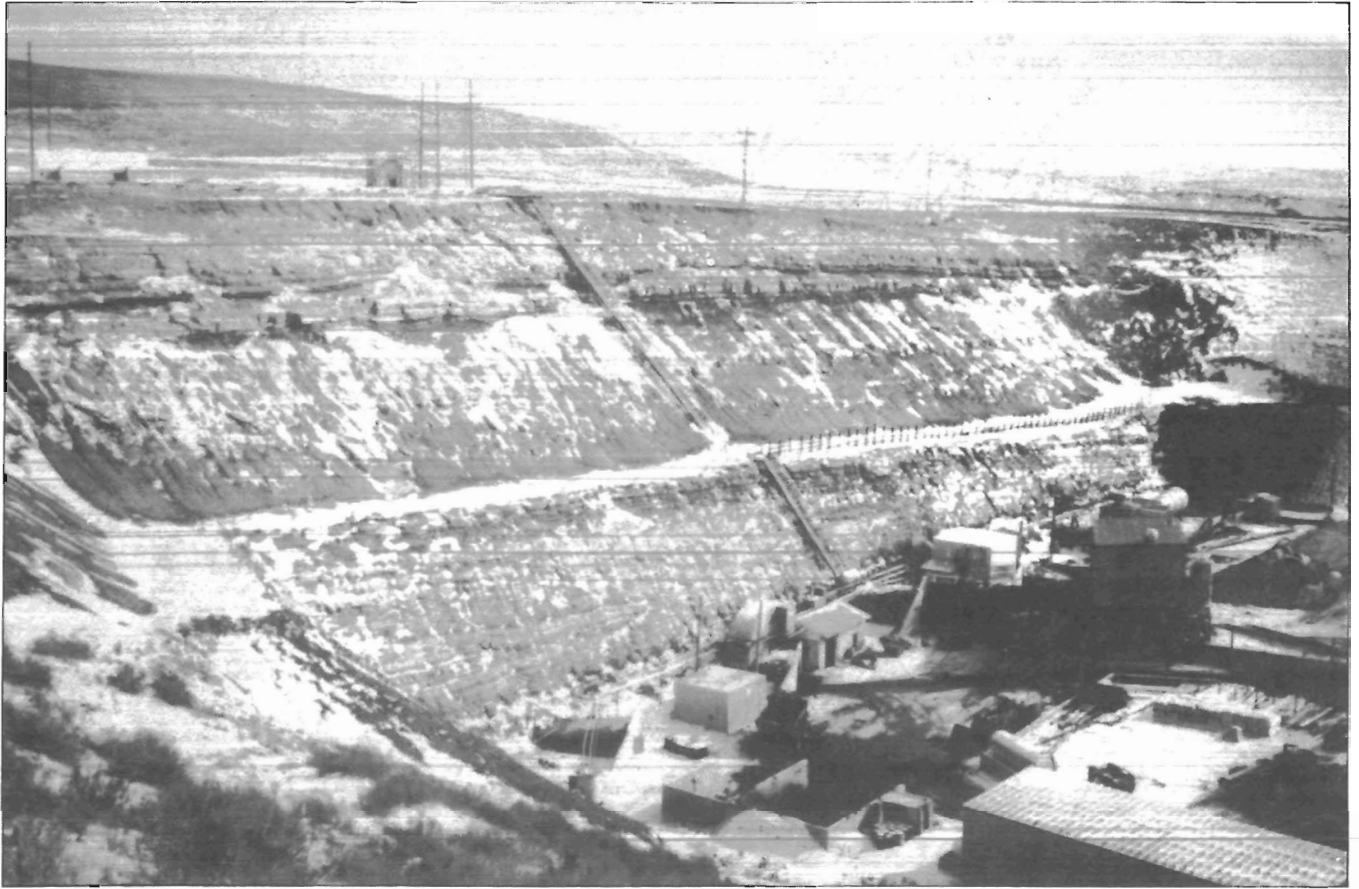
Figure 6

Overburden strata exposed in old strip mine highwall at Shoshone No. 1 Mine portals. Immediate roof mudstone lies between level of portals and bench across face of highwall. Thin siltstone layer forms road base of bench. Sandstone strata at about three-fourths of highwall height is lowest competent strata in main mine roof. (Photo: Liane Kadnuck, Denver Research Center, U.S. Bureau of Mines)

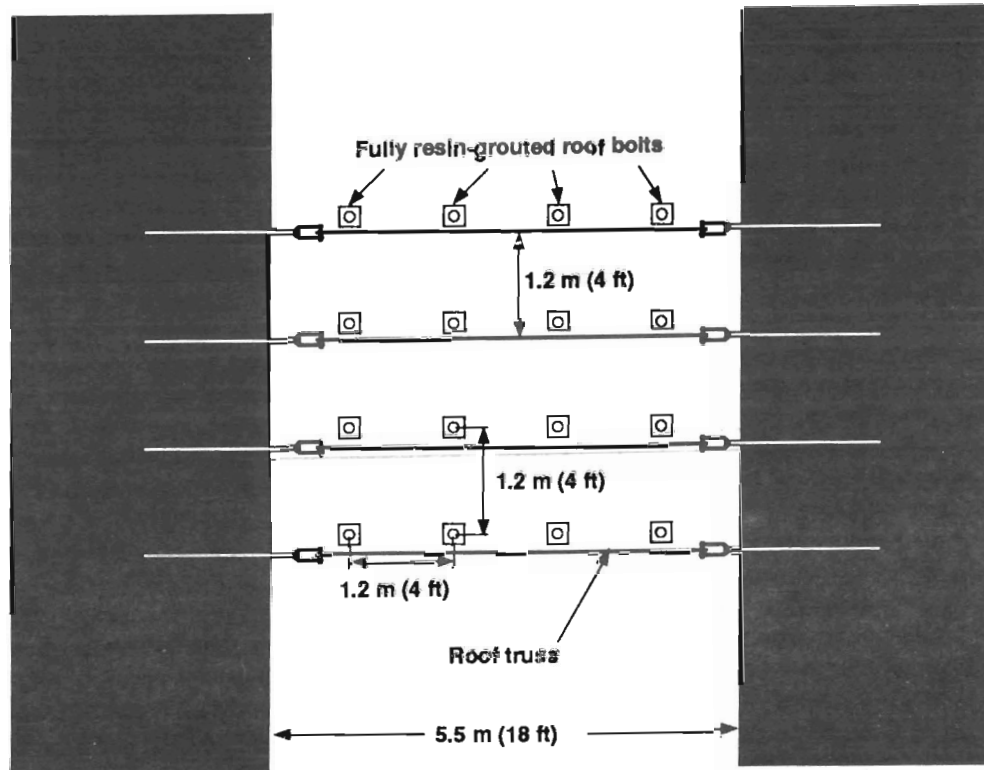
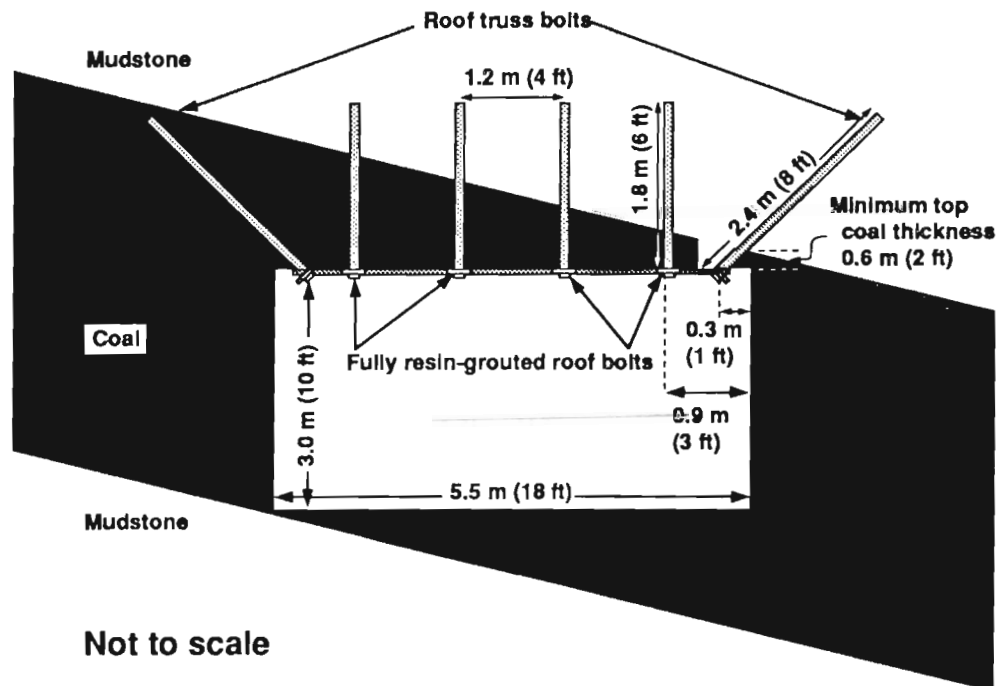
Figure 7

Primary roof support and entry configuration for Shoshone No. 1 Mine gate road entries.
Top, plan view; bottom, cross section view.

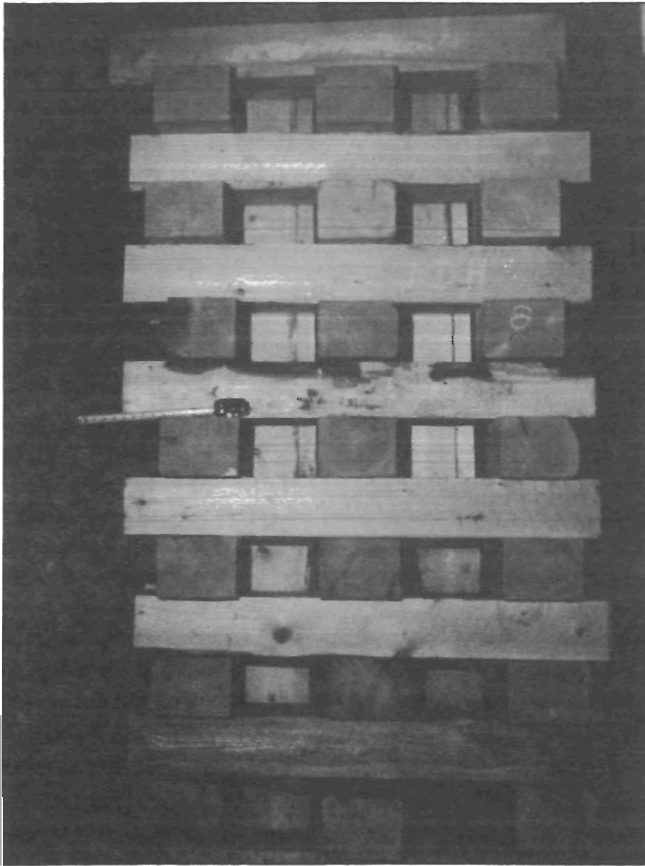
Figure 8

Confined core wooden crib used for secondary support in tailgate entry of 11th Left longwall panel. (Photo: William Wuest, Denver Research Center, U.S. Bureau of Mines)

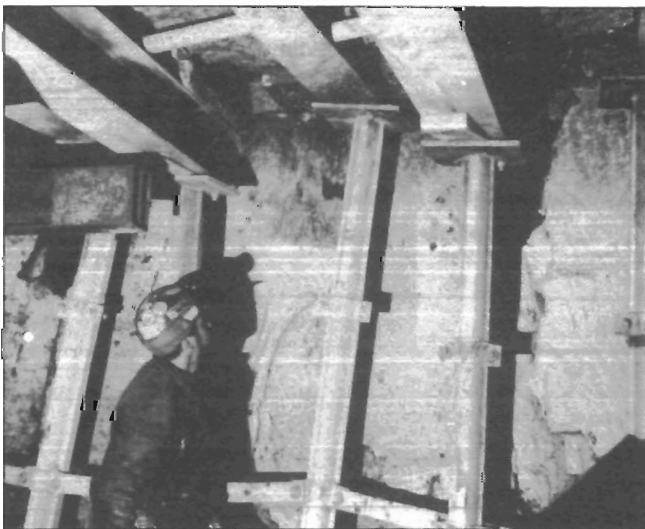
Figure 9

Steel beams with yieldable steel legs used for secondary gate-entry support. (Photo: Greg Molinda, Pittsburgh Research Center, U.S. Bureau of Mines)

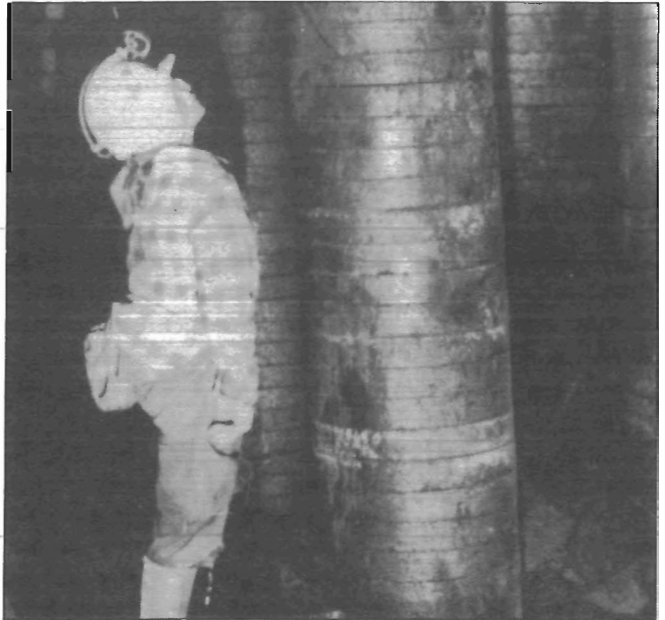
Figure 10

Concrete donut crib used for secondary support (on trial basis) in tailgate entry of 11th Left longwall panel. (Photo: William Wuest, Denver Research Center, U.S. Bureau of Mines)

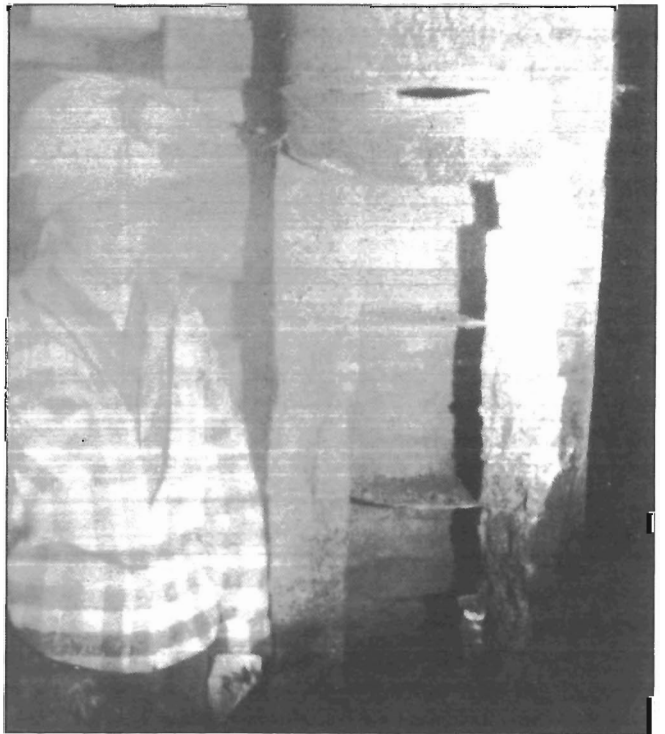
Figure 11

Concrete donut crib that has failed in compression and split vertically. (Photo: William Wuest, Denver Research Center, U.S. Bureau of Mines)

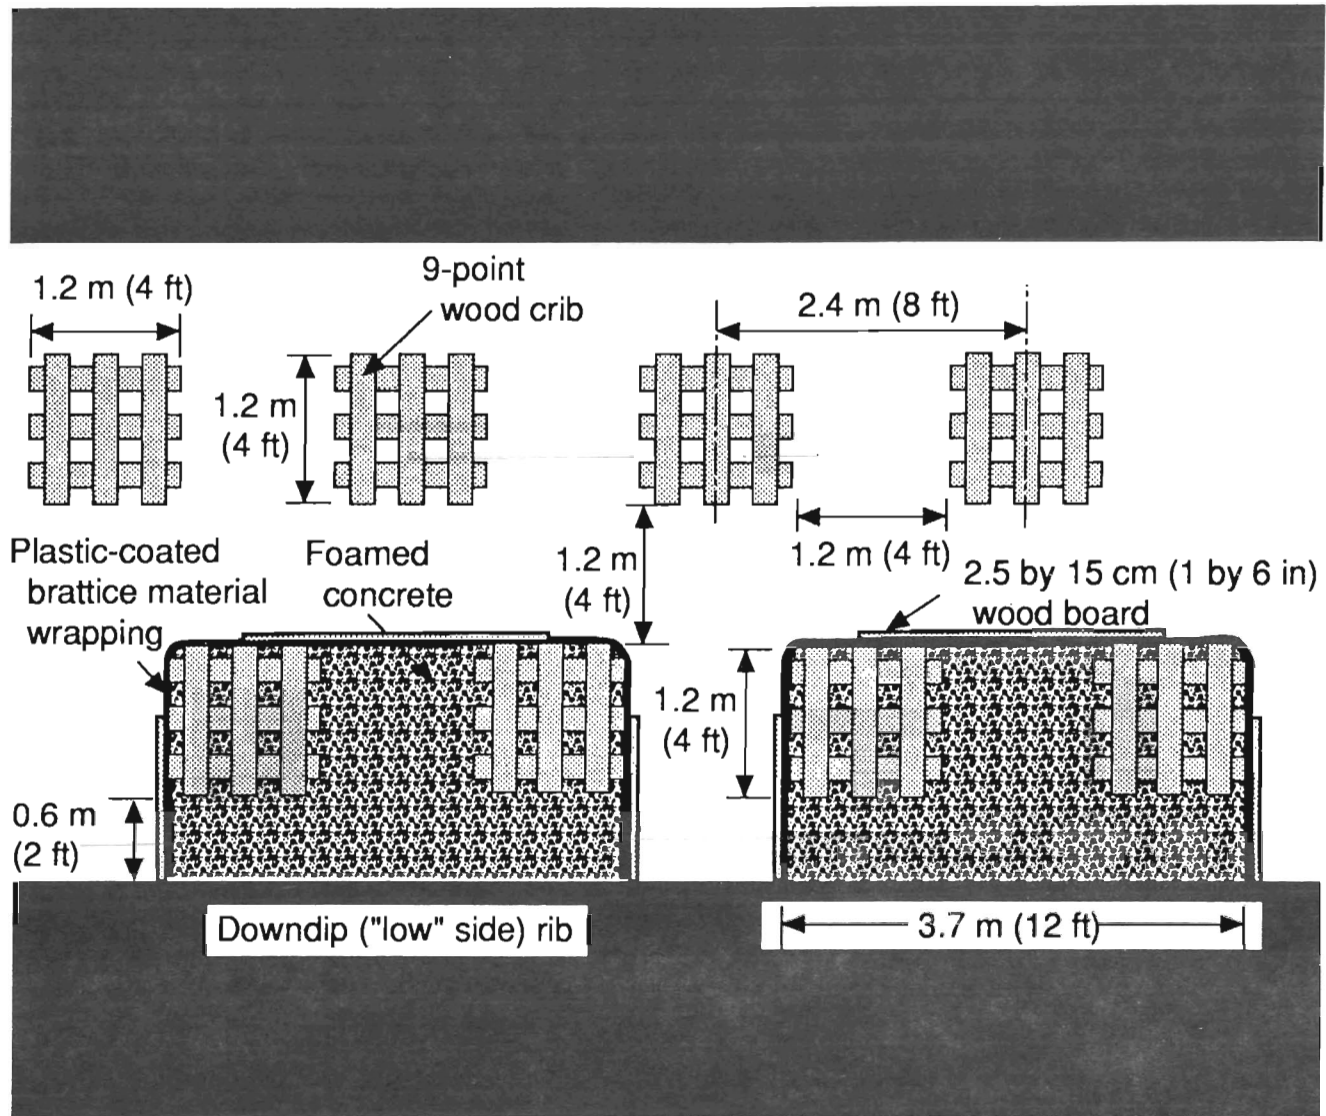
Figure 12

Cribbing pattern used for secondary support in tailgate entry of 11th Left longwall panel, showing configuration and position of wood-foamed concrete composite cribs.

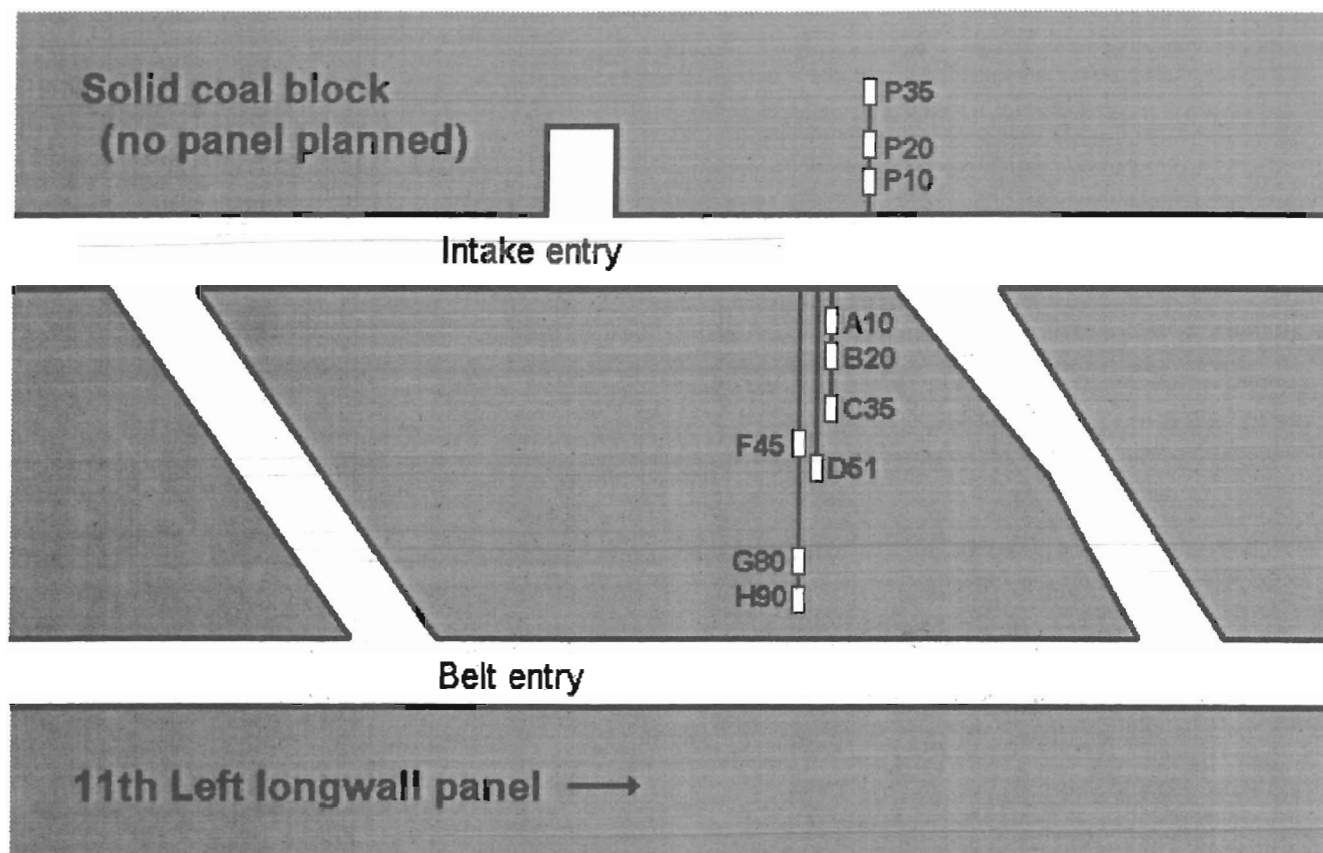
Figure 13

Study site instrumentation in 11th Left gate road.

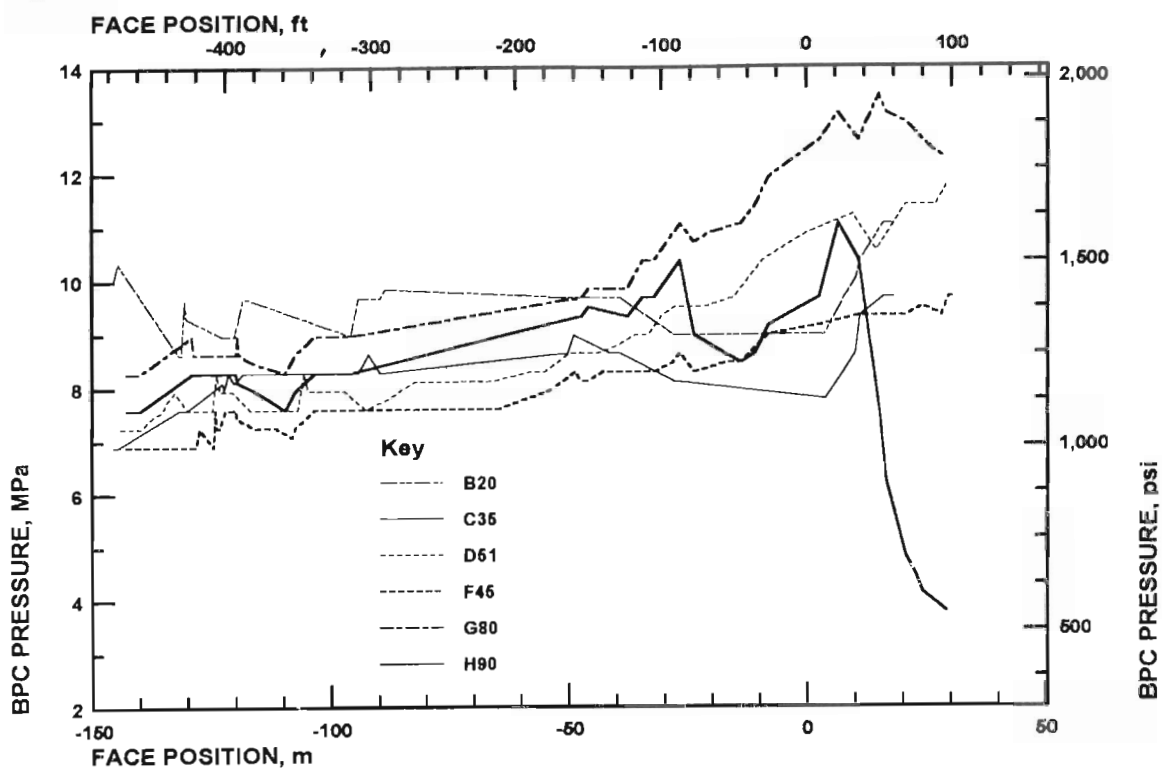
Figure 14

Vertical pressure relative to 11th Left panel face position at study site pillar.

In the site pillar (figure 14), recorded pressures for all six BPC's were somewhat erratic from the beginning of monitoring at face position -146 m (-480 ft) to face position -98 m (-320 ft), at which point pressures stabilized and rose steadily until the face was about 49 m (160 ft) inby the site. The greatest degree of pressure fluctuation occurred from -146 to about -122 m (-480 to -400 ft). Interestingly, during this period, the panel face was progressing through an area of extremely poor roof conditions in the 11th Left headgate entry; consequently, the face advanced only about 1.4 m (4.7 ft) during each day of this period. When the face progressed into more favorable headgate roof conditions, the face advanced approximately 5 m (16.4 ft) during each day and pressure fluctuation decreased. These fluctuations could possibly be attributable to effects on the pressure recording mechanisms from vibrations caused by a winch or mobile equipment traffic in the same crosscut as the pressure chart recorders during the extended period of slow face progression.

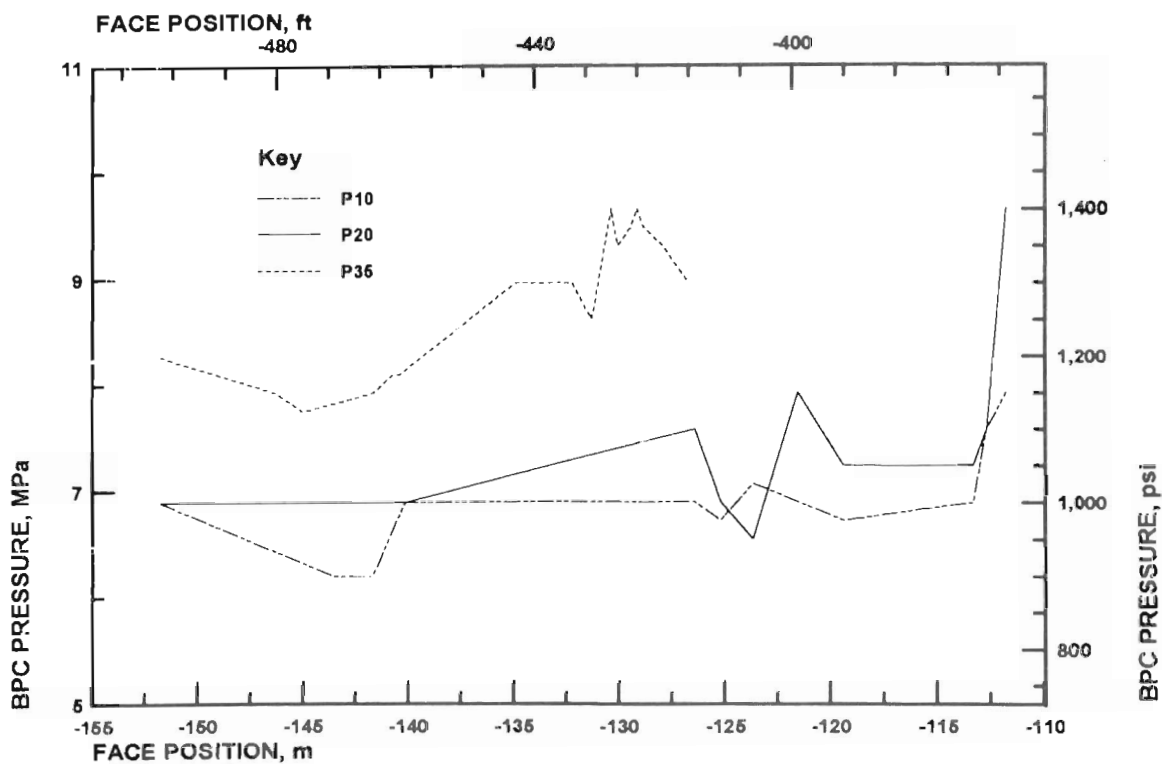
Figure 15

Vertical pressure relative to 11th Left panel face position at solid coal block opposite study site pillar.

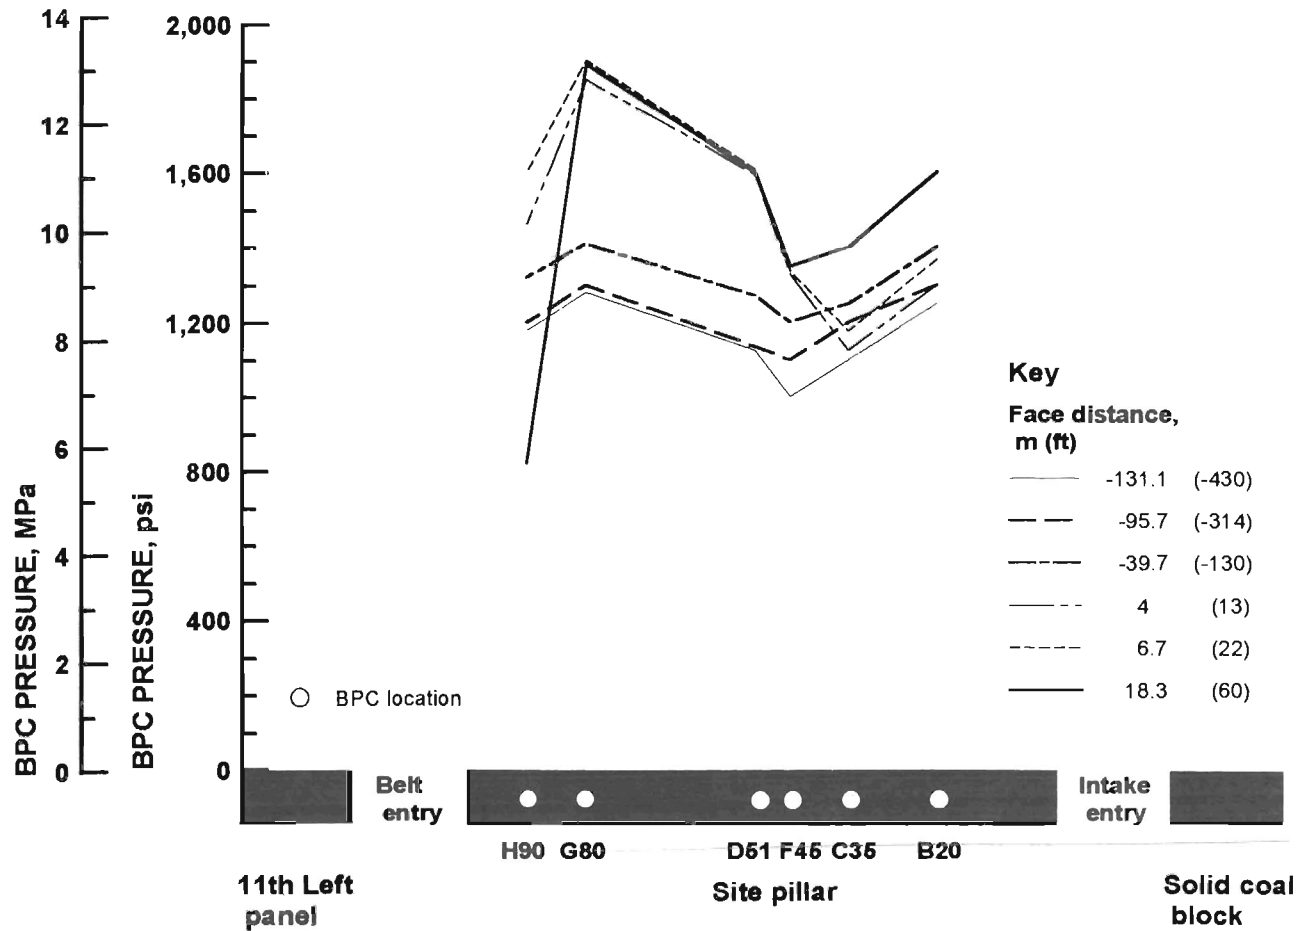
Figure 16

Vertical pressure profiles at site pillar for selected face positions (looking inby).

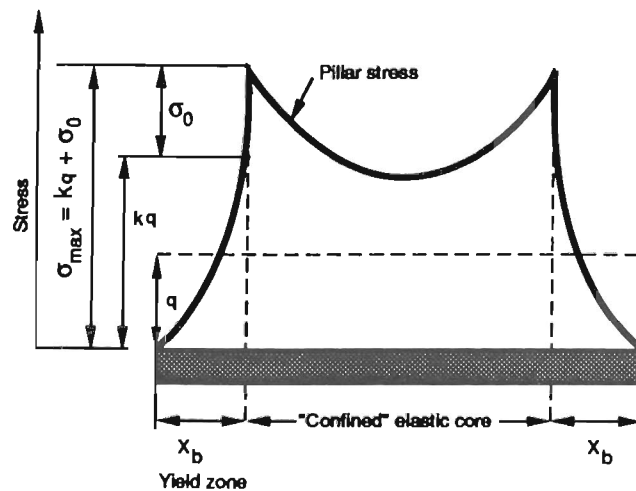
Figure 17

Conceptual vertical stress profile for Wilson's confined-core pillar. [From Carr and Wilson (25)]

The load configuration across the pillar indicated by the initial BPC pressure profile at face position -131.1 m (-430 ft) generally conforms to the "confined-core" pillar loading geometry (figure 17) postulated by A. H. Wilson, noted British ground control authority (24-25). For a yielding roof and floor (definitely the Shoshone mining environment), Wilson's equations are:

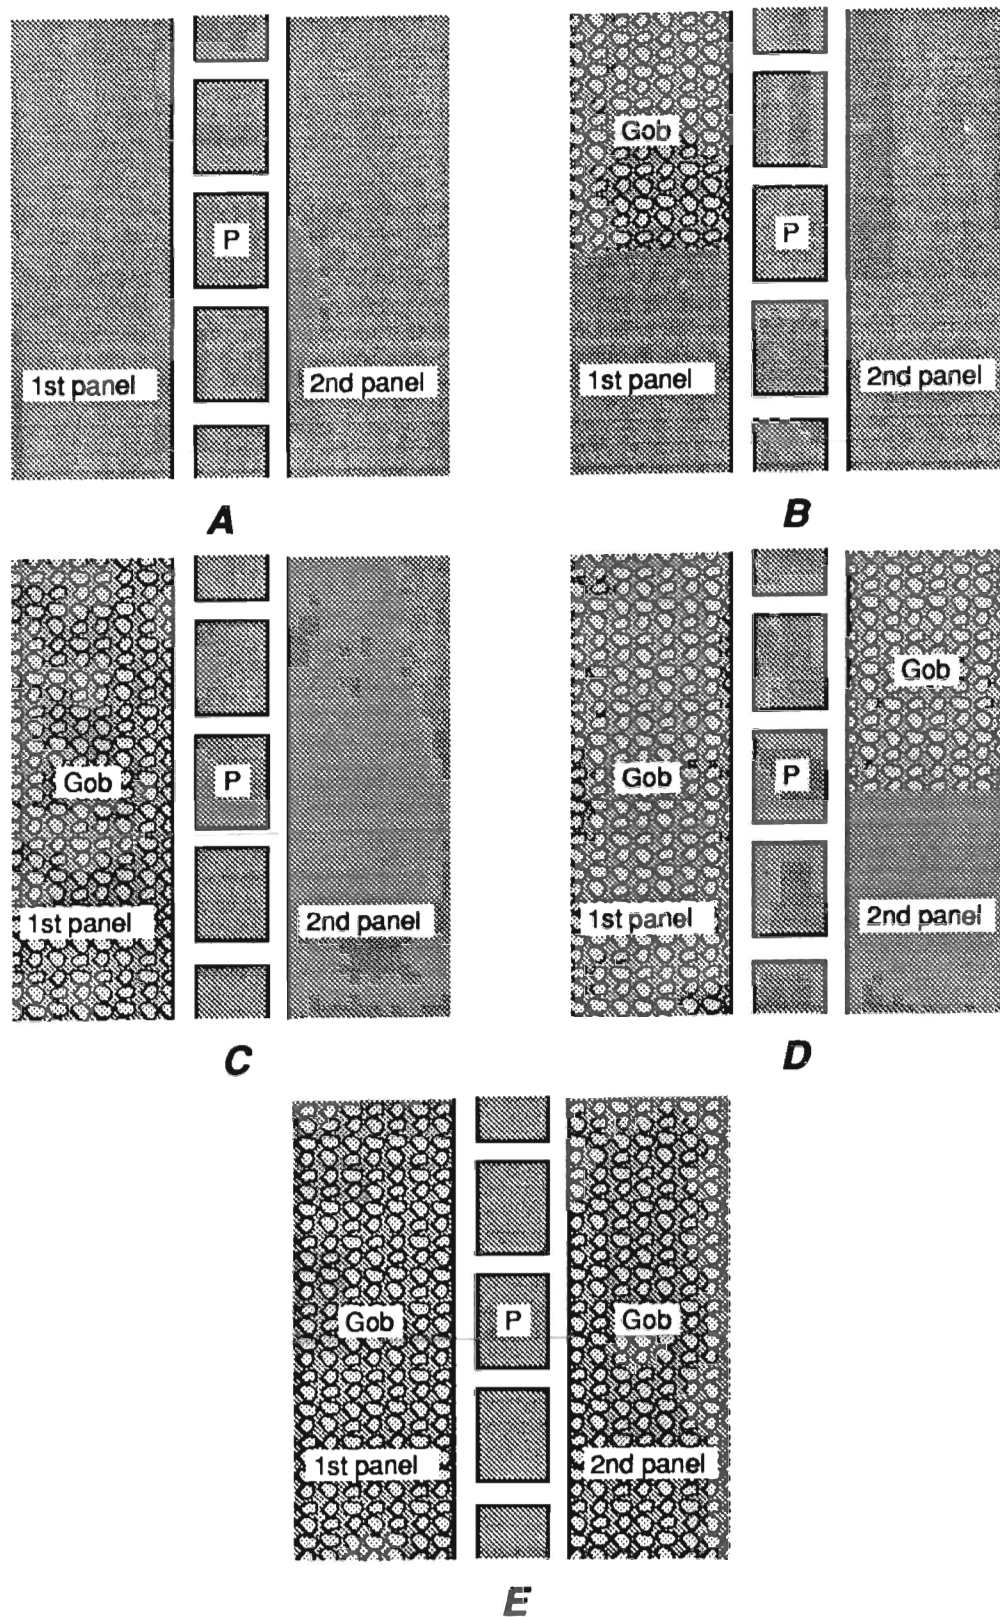
Figure 18

Sequence of ALPS loading conditions for pillar P in two-entry gate road. A, Development loading; B, headgate loading; C, bleeder loading; D, tailgate loading; E, isolated loading.

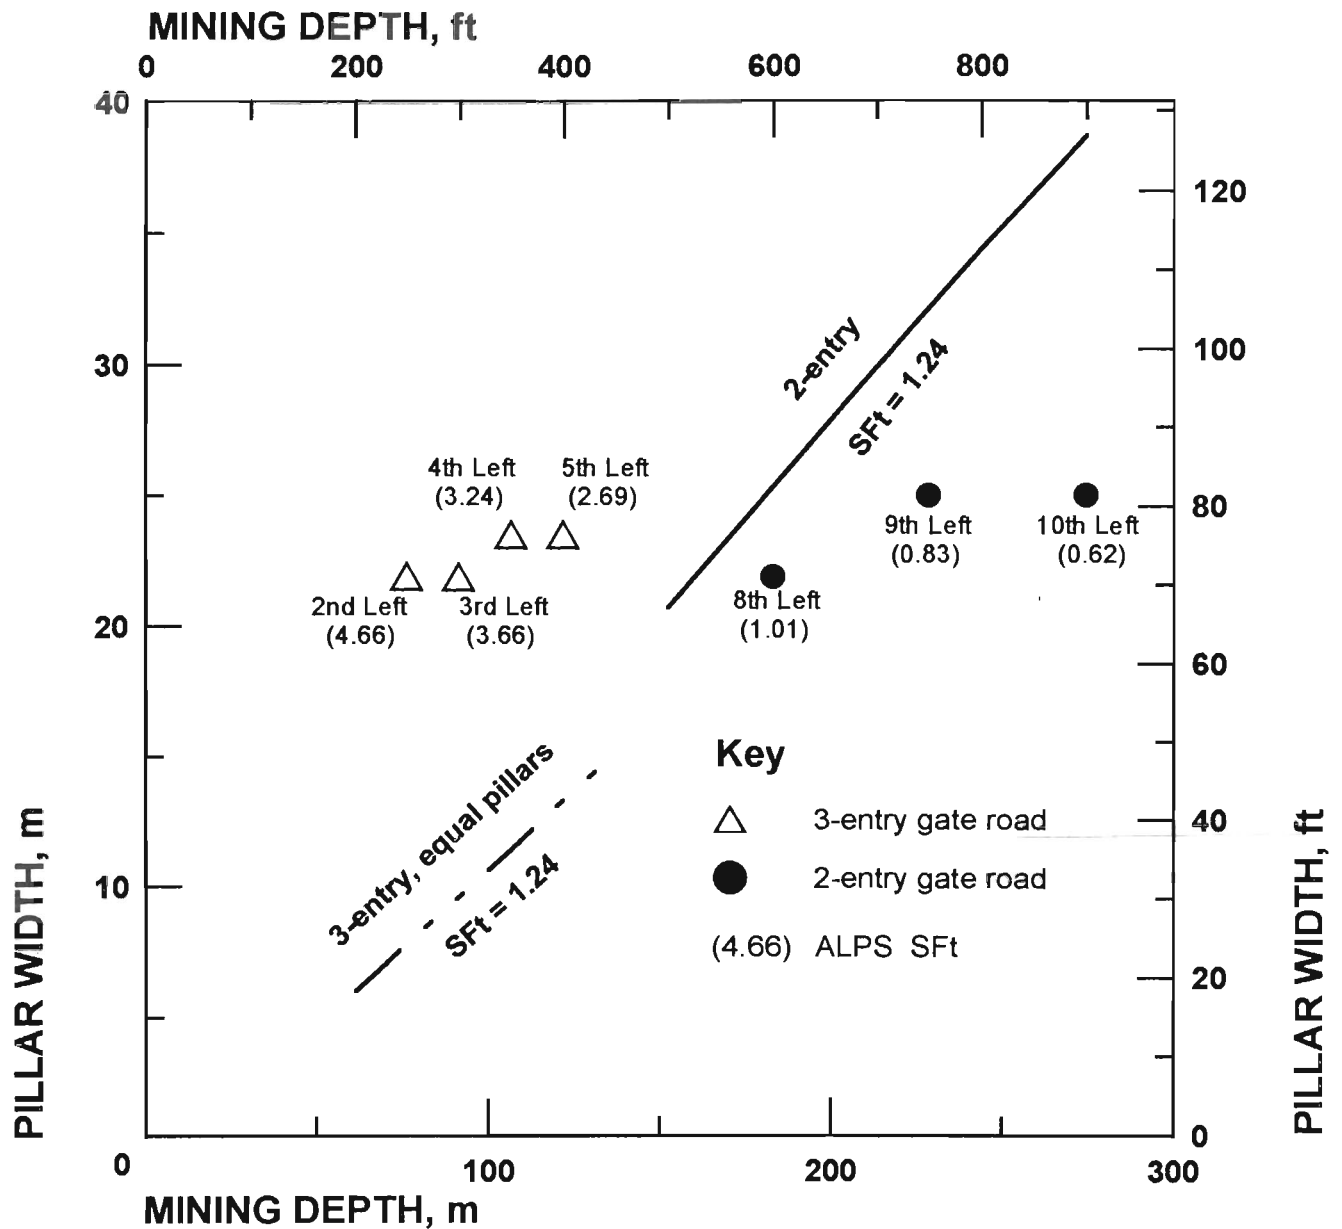
Figure 19

Chain pillar width and ALPS Sf of second-panel-mining tailgate roads for Shoshone No. 1 compared to equation 5 criterion for 0.61-m (2-ft) top coal thickness (CMRR = 37).

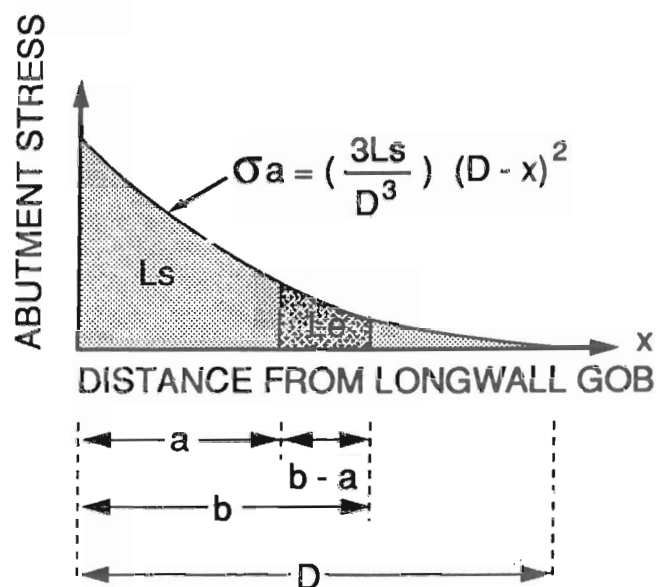
Figure 20

- σ_a Abutment stress distribution function
- L_e Abutment load on entry
- D Extent of side abutment influence zone
- x Distance from edge of longwall gob
- L_s Total side abutment load
- a Width of chain pillar in 2-entry gate road
- $b - a$ Width of entry
- b Distance from edge of longwall gob to tailgate rib of next longwall panel

Distribution of side abutment load for two-entry gate road

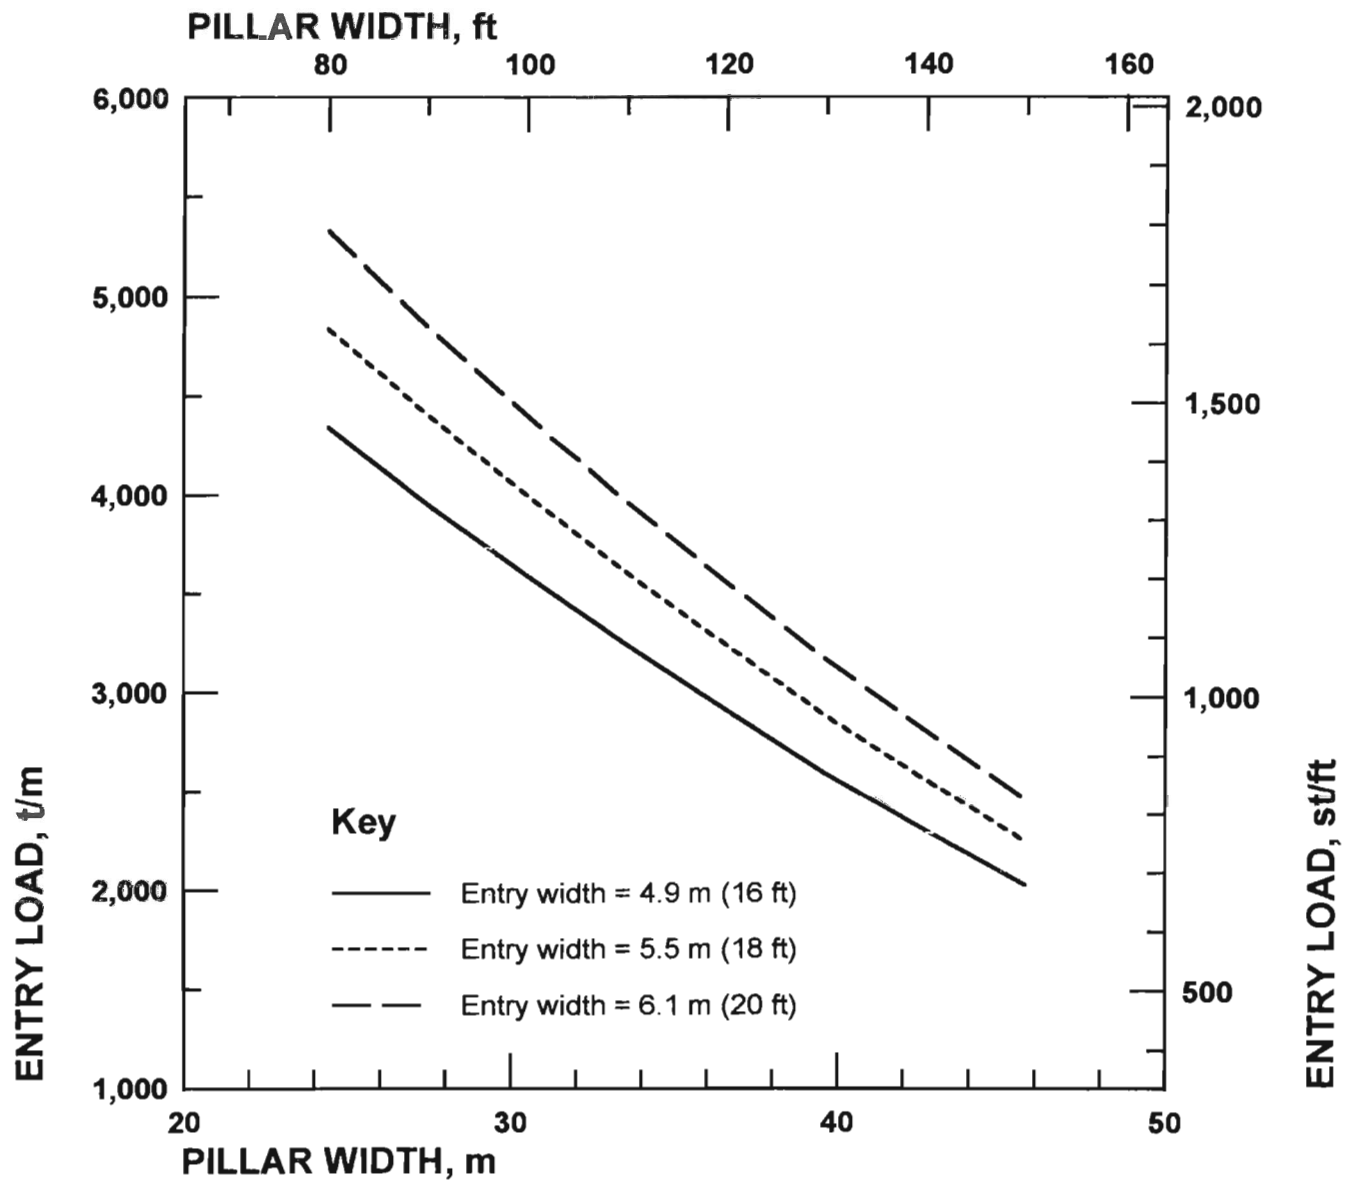
Figure 21

Hypothetical side abutment loading from first-panel mining (ALPS SFb) on second-panel tailgate entry in two-entry gate road. Mining depth is 335 m (1,100 ft).

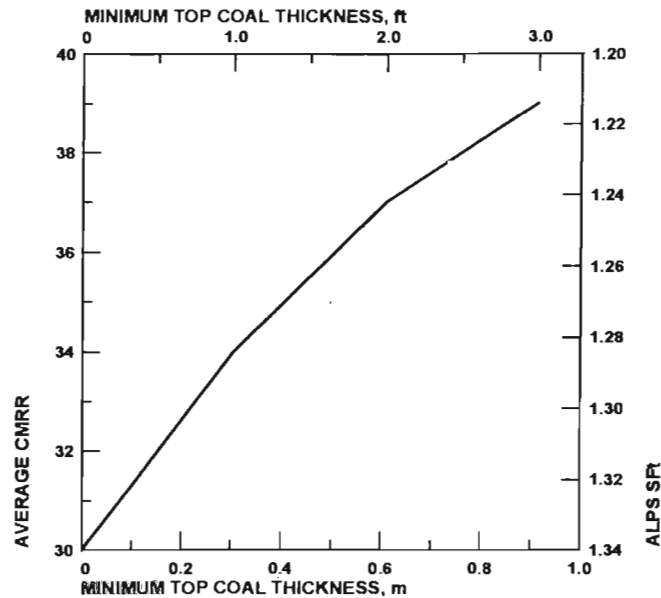
Figure 22

Average CMRR and ALPS SFt (from equation 5) relative to minimum top coal thickness for Shoshone No. 1 Mine gate roads.
